From: s. 47F(1) @police.qld.gov.au [mailto:s. 47F(1)@police.qld.gov.au]
Sent: Thursday, 9 June 2016 6:19 PM
To: ASIRFollowup <ASIRFollowup@atsb.gov.au>
Subject: Aviation Incident at Imbil

ATSB Reference: 201600858 **Category:** Accident
Investigation: No
Date and Time: Thursday, June 09, 2016 12:18 PM EST
Location: Sunshine Coast Aerodrome, 294° M 47Km (Melawondi Rd)
State: QLD **Country:** Australia
Latitude: -26.3608 **Longitude:** 152.7045
Highest Injury: Serious
Occurrence: Operational - Terrain Collisions - Collision with terrain
Site Access: Accessible
Dangerous Goods: Nil

Summary: During approach, the aircraft struck a fence and subsequently collided with terrain, resulting in substantial damage to the aircraft and injuries to the pilot and passenger.

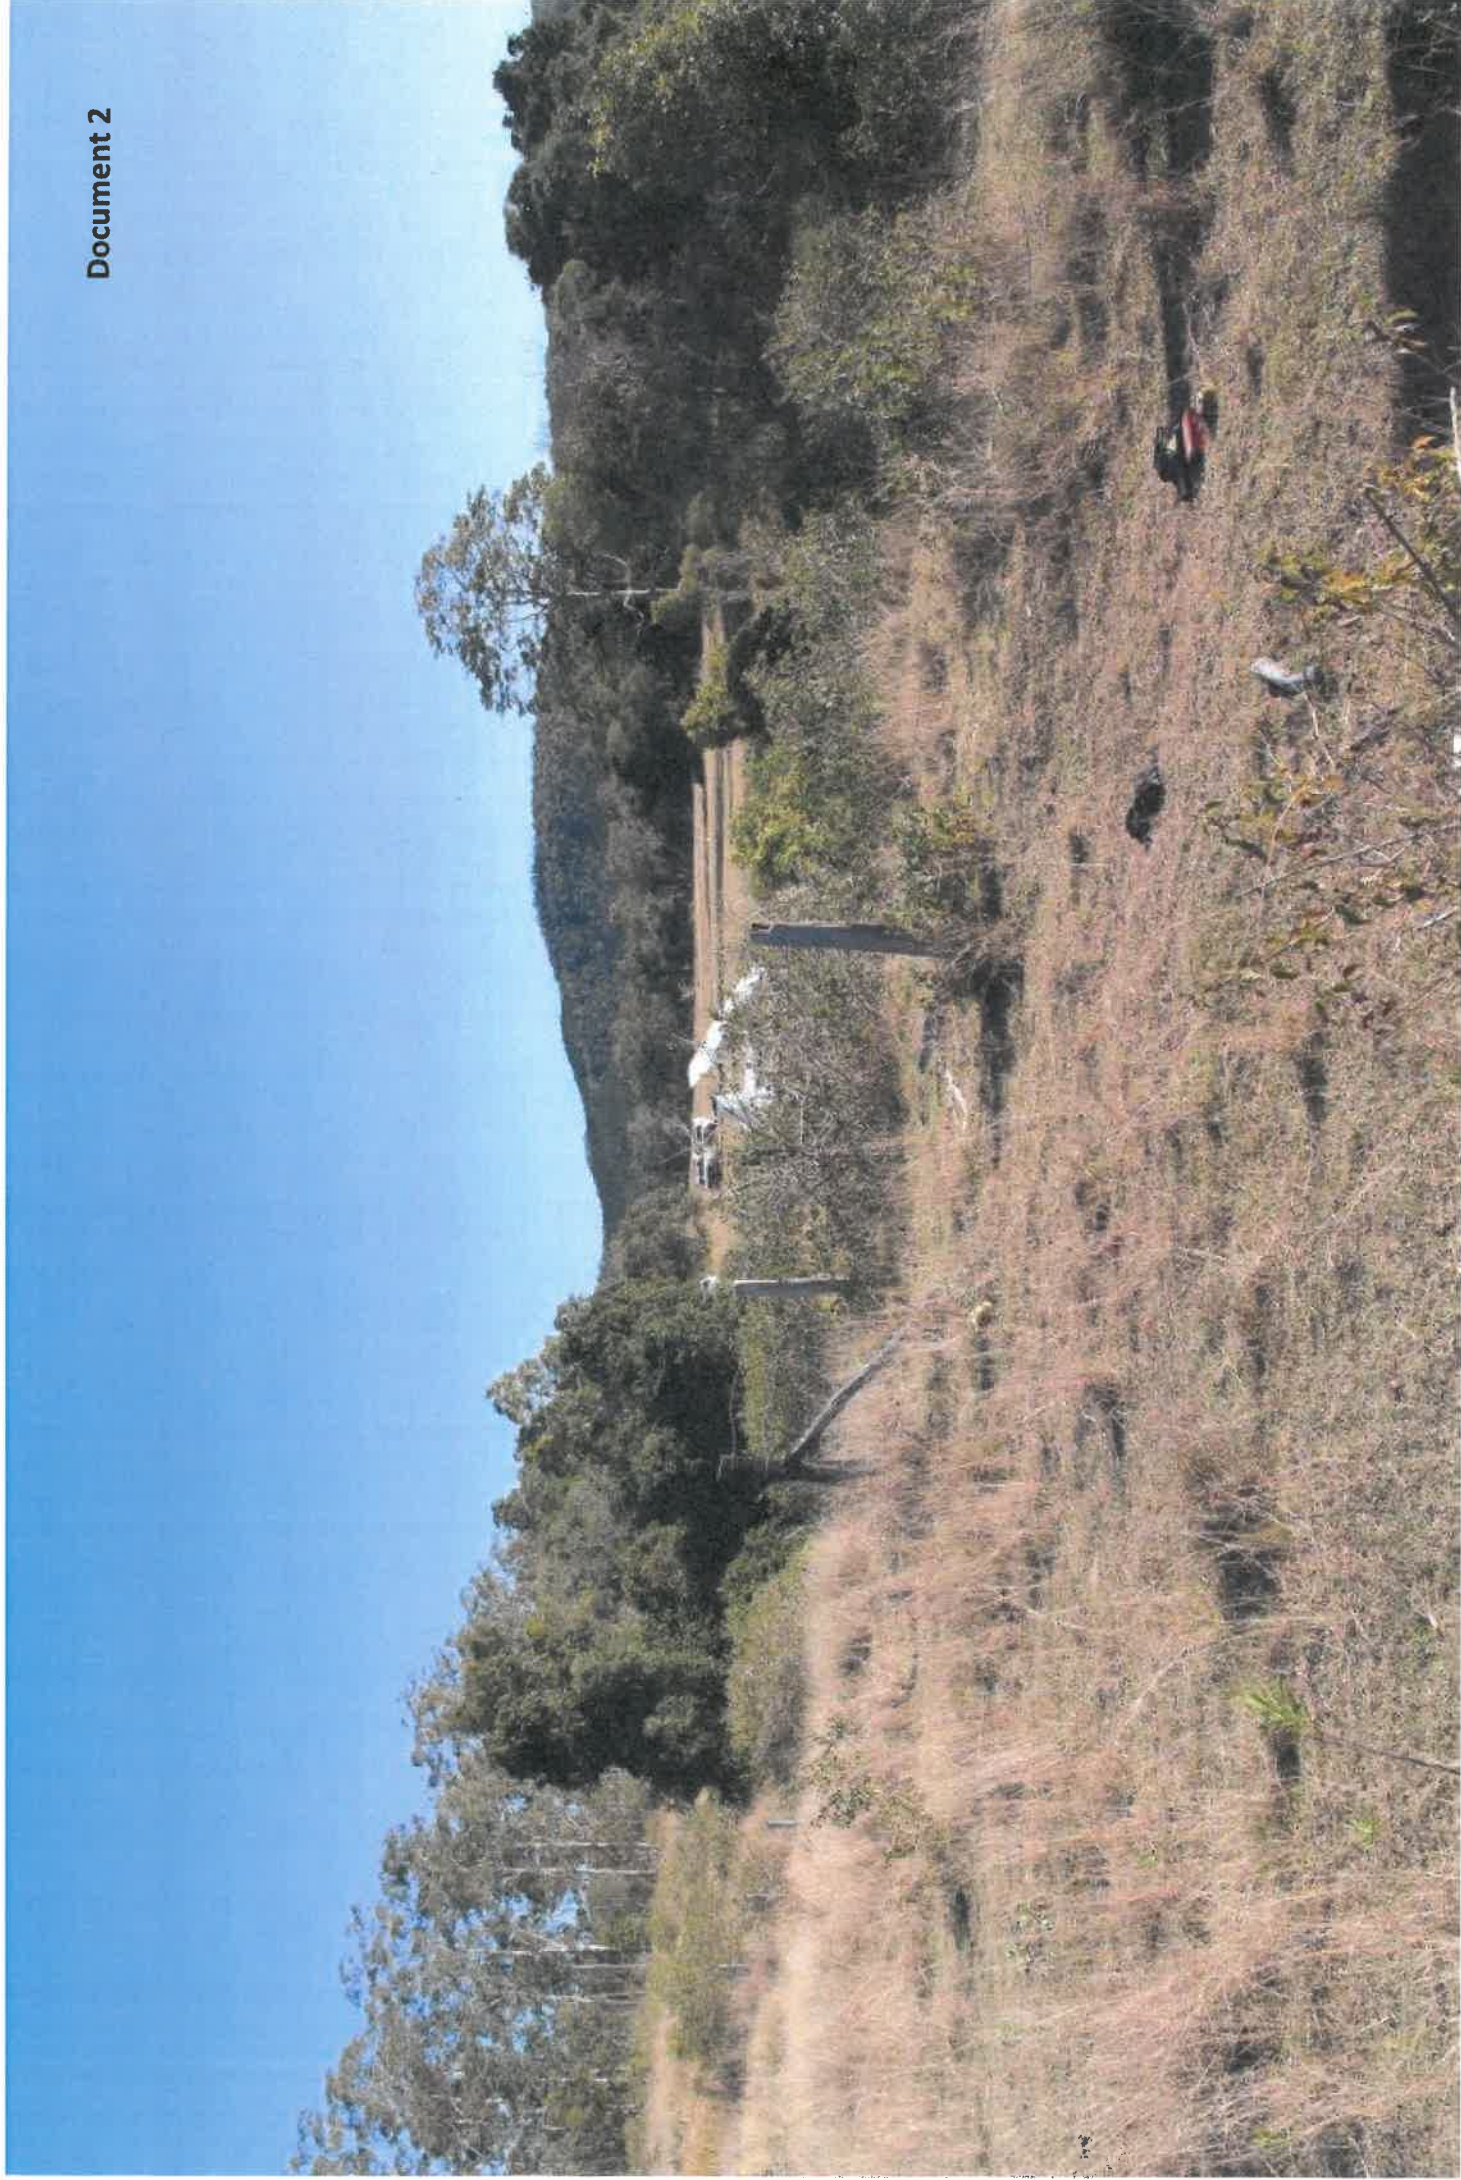
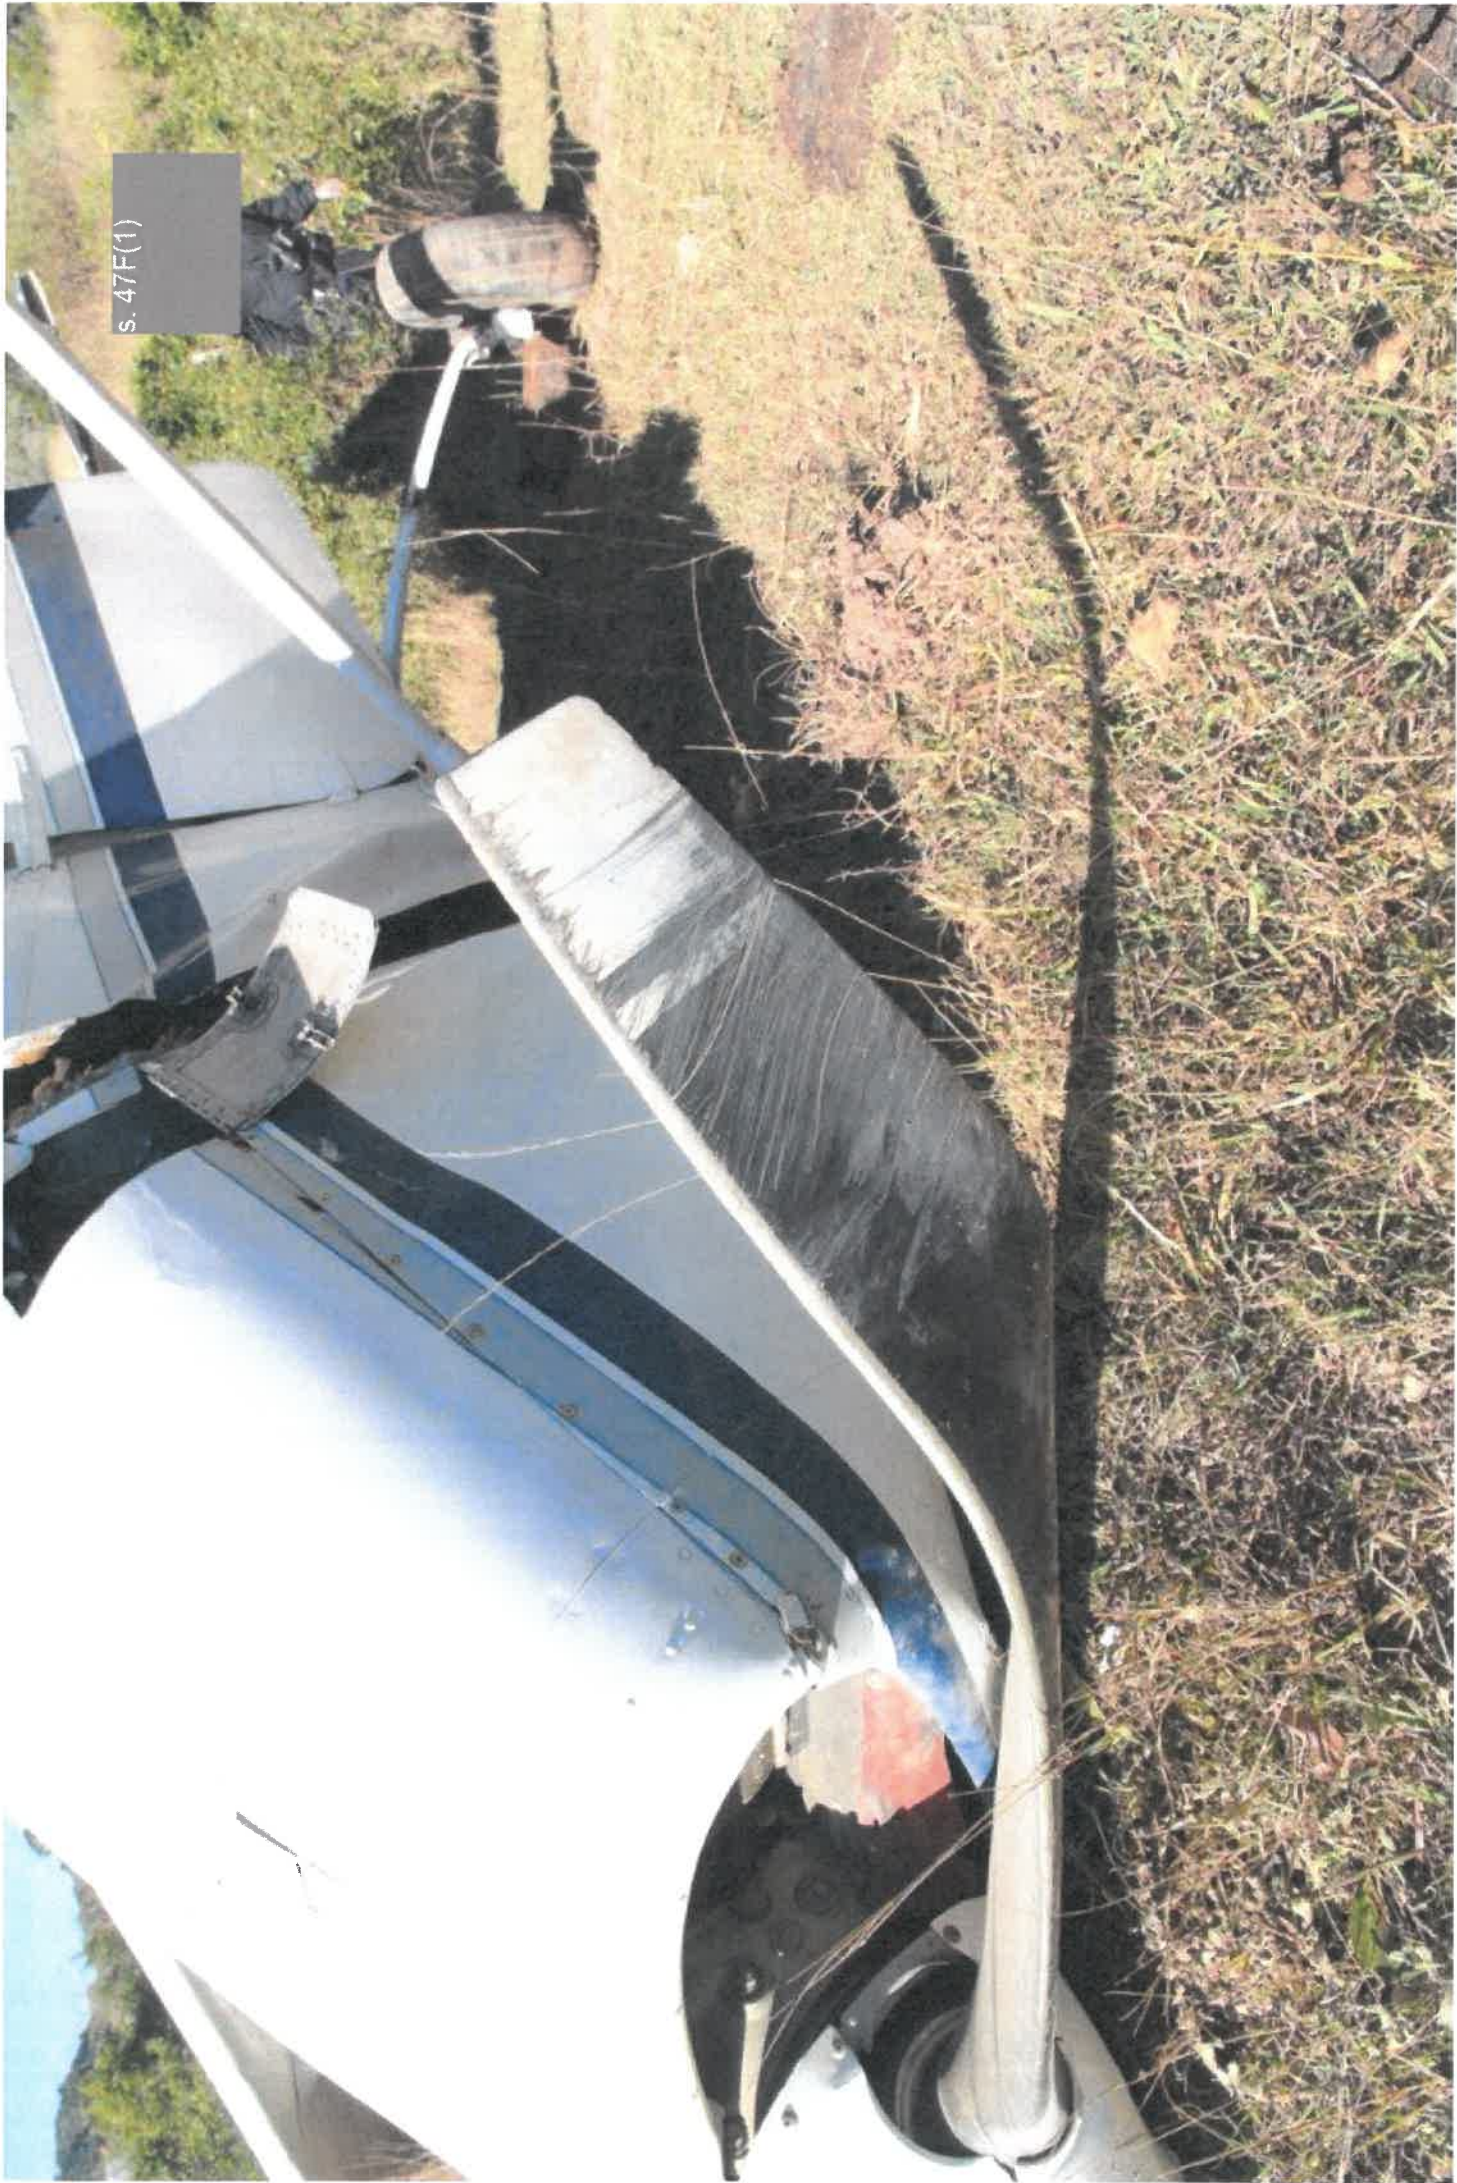
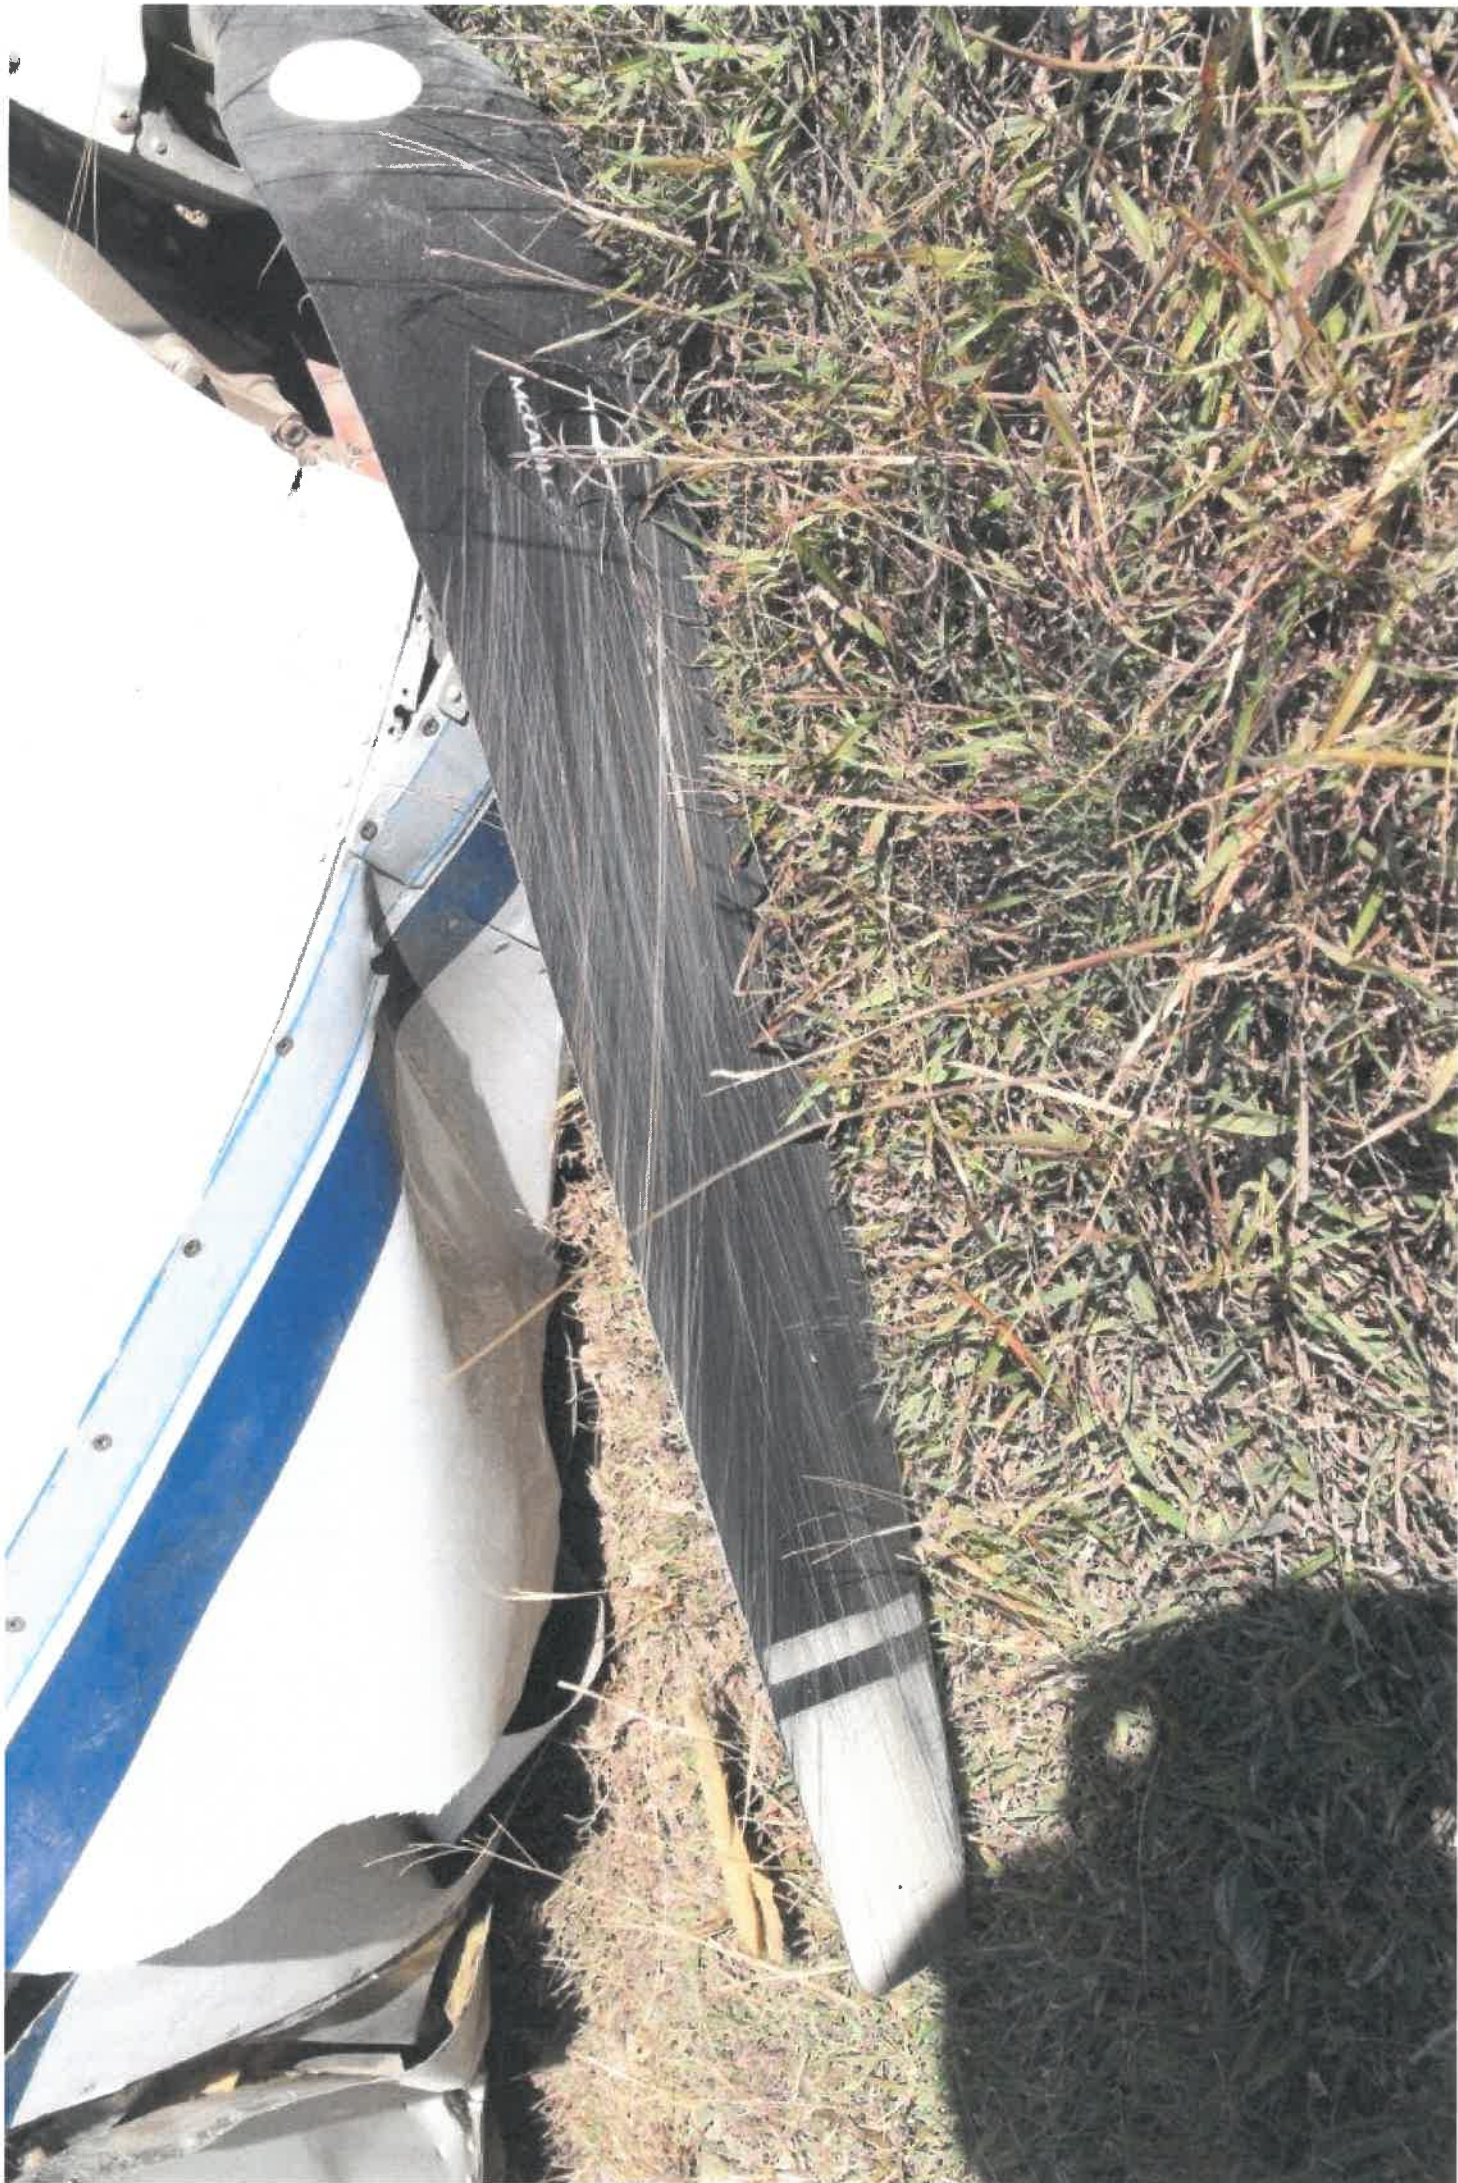
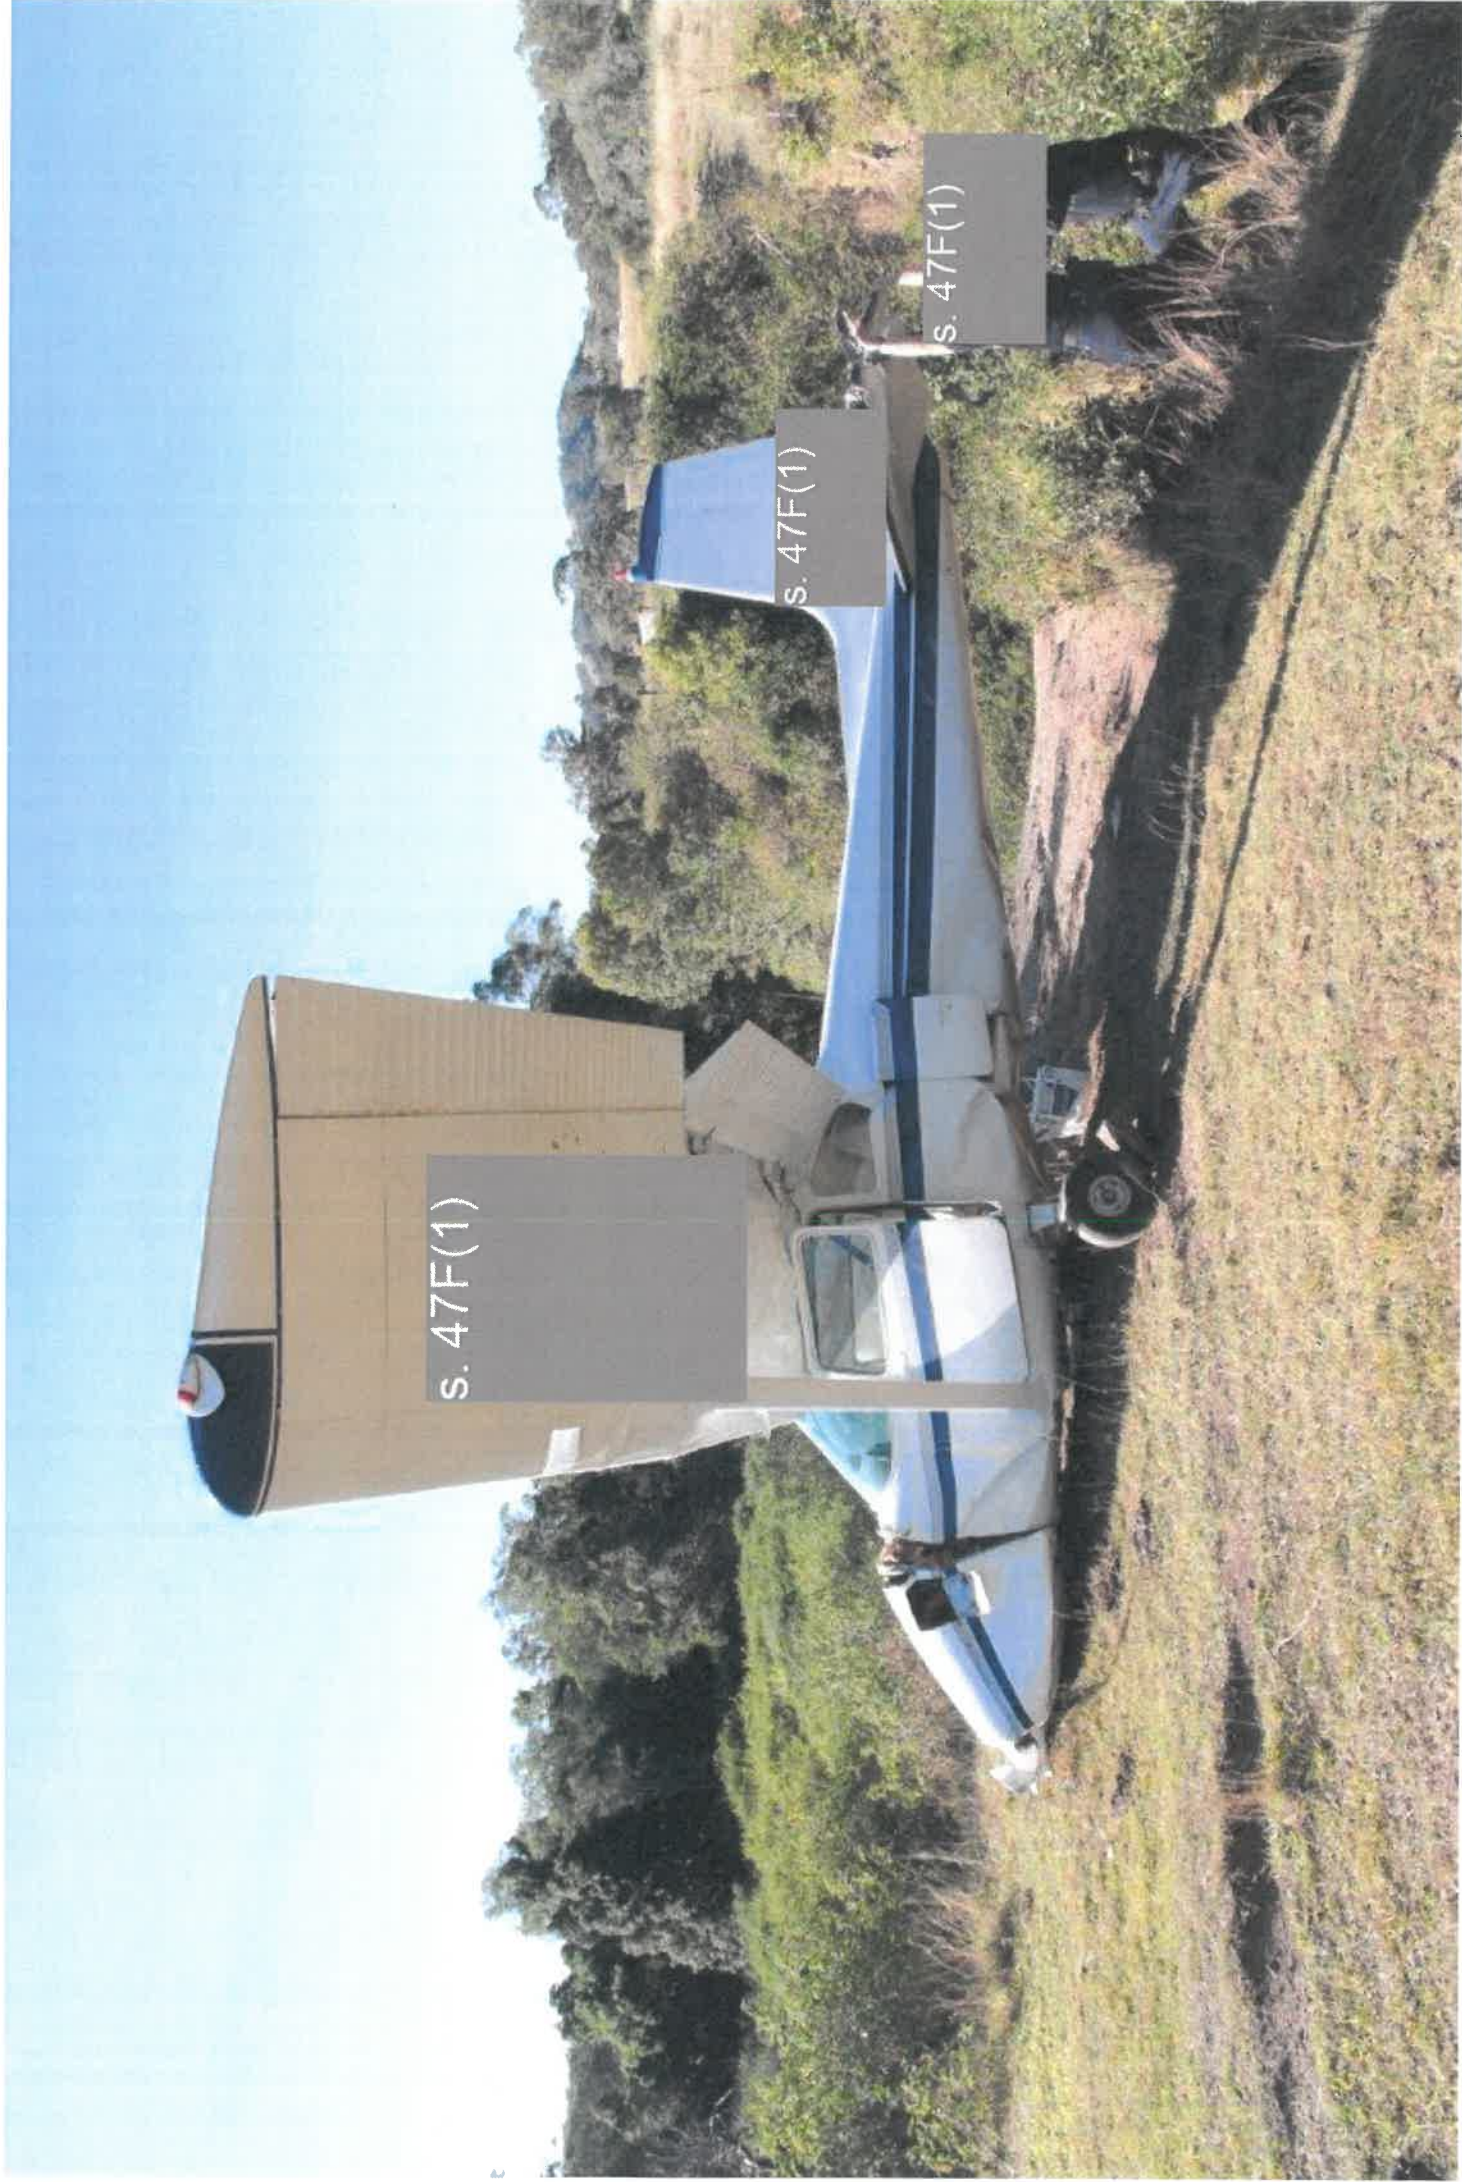
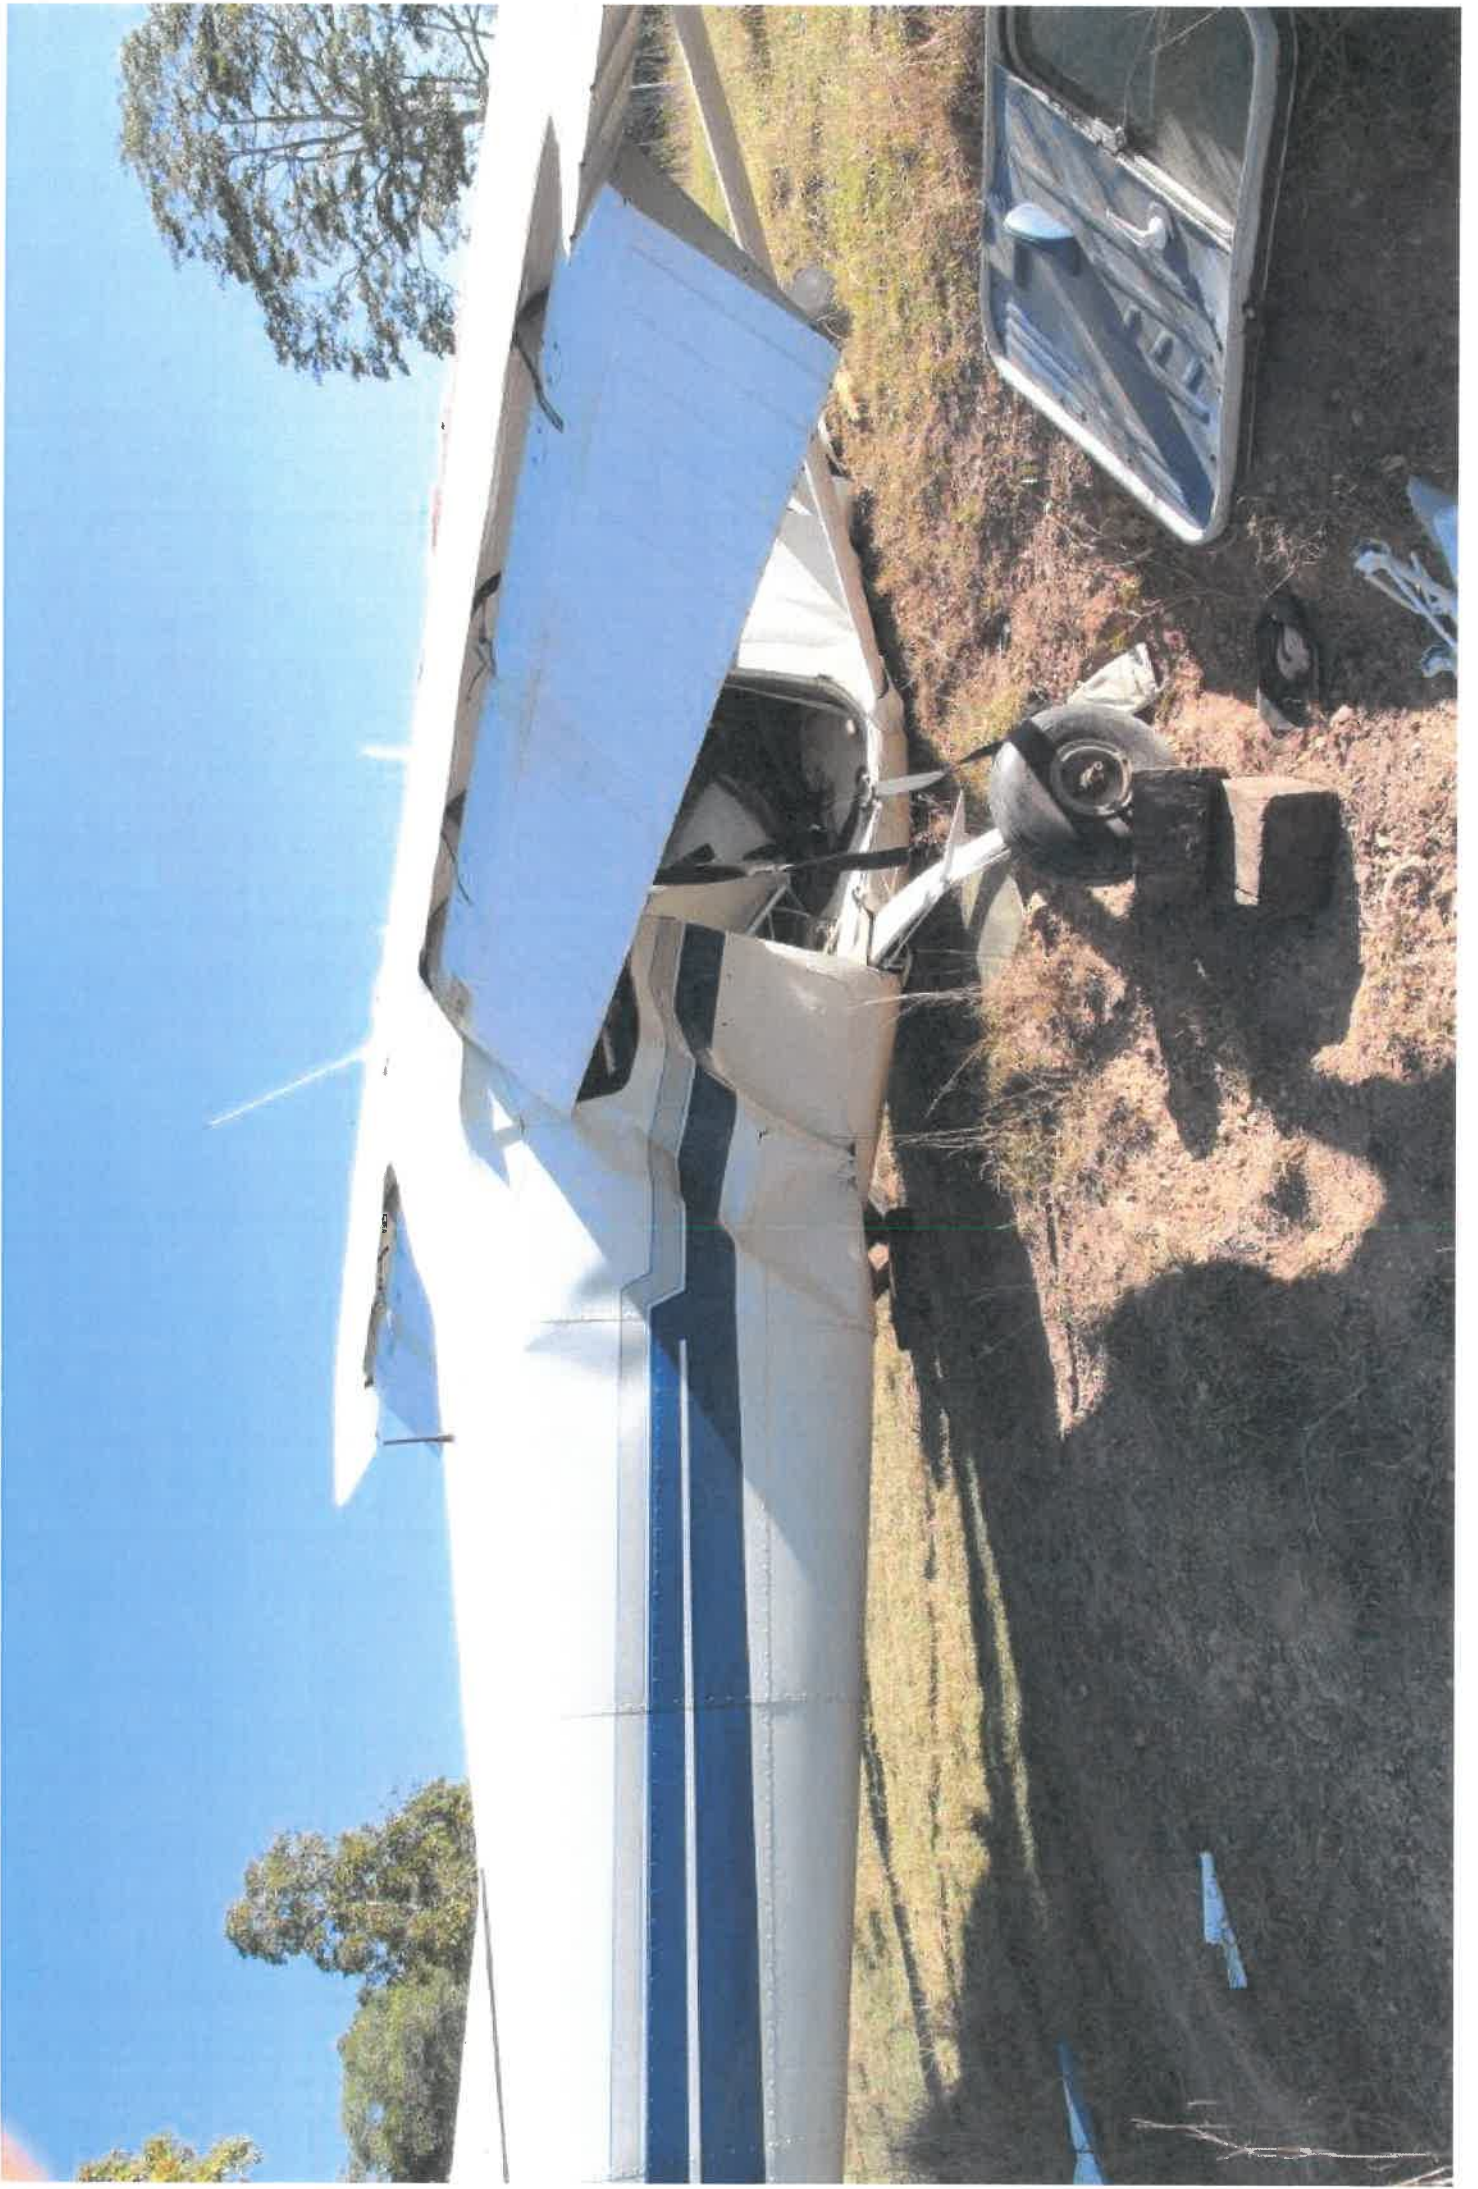
Image 5897 is taken facing the direction of travel of the aircraft. The fence post in the centre-foreground was struck by the right hand horizontal stabiliser which is shown in Image 5909.

The left hand extremity of the left hand horizontal stabiliser also clipped a wooden fence post which tore a piece of the stabiliser off the aircraft.

Image 5903 and 5904 show the scrape marks on the face of the propeller blades and their damage.
