Safety Advisory Notice

Number: RO-2020-022-SAN-002

Unknown functions in locomotive braking systems

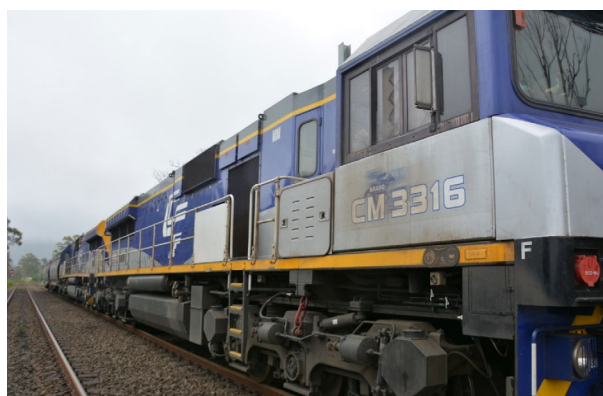
Runaway locomotives (Source: ATSB)

RO-2020-022-SAN-002: The ATSB advises that all Rollingstock Operators (RSO) should review specifications and test locomotives under their control to understand how the braking systems are configured. RSOs must communicate this knowledge through their organisation's procedures and training material to ensure train crew knowledge and competence in operating various locomotive braking systems.
